6 Process Monitoring and Troubleshooting with KODAK Control Strips, Process RA-4

Using KODAK Control Strips, Process RA-4, with KODAK EKTACOLOR EDGE Paper

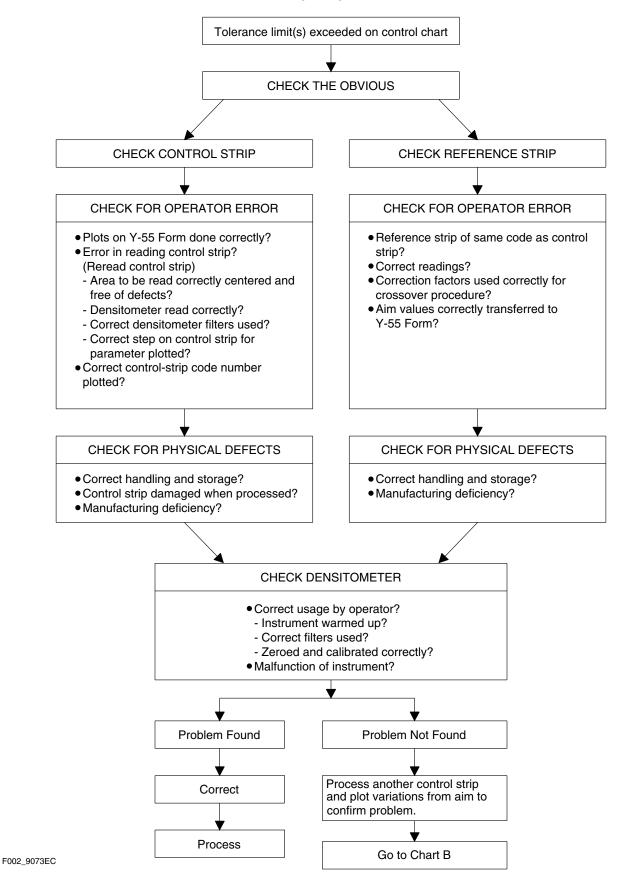
Chart	Title
А	Preliminary
В	Summary—Control-Chart Plots
С	Control-Chart Plots—High BP, HD-LD, or LD
D	Control-Chart Plots-Low BP, HD-LD, or LD
E	Control-Chart Plots—High D-min
F	Control-Chart Plots—Visual Appearance—Developer and Bleach-Fix
G	Control-Chart Plots—Visual Appearance of Paper
Н	Control-Chart Plots—Visual Appearance of Paper
I	Control-Chart Plots—Visual Appearance of Paper
